# Manhole Inspection Summary

Manhole # S49GG\_044MH

Insp Date: **8/11/08 9:43 AM**

**Location** Address: **Milton**

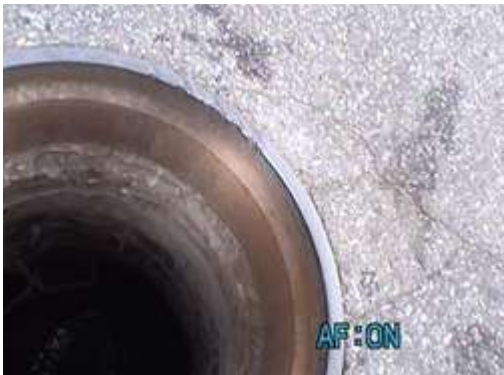
Defect 1

infiltration

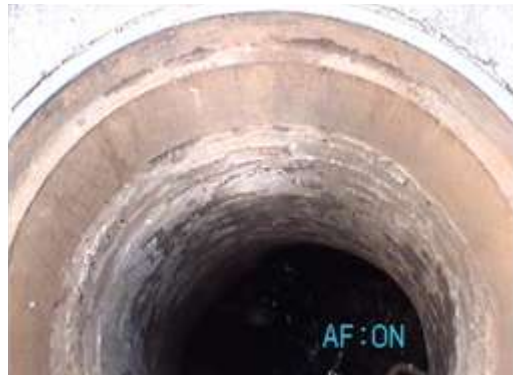
Defect 2

frame leaks

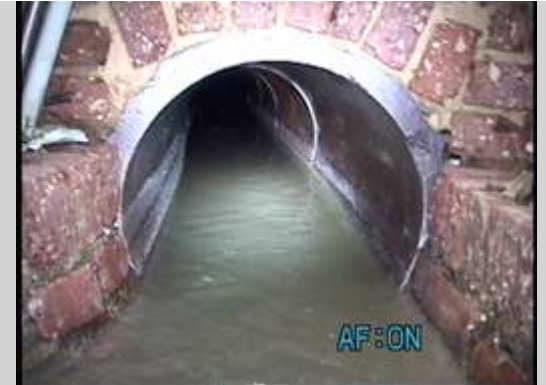
12 O'Clock Outflow

15 in. Circular Gravity Sewer  
Pipe Out @ 12 O'Clock

Pipe Height: **15.6** (in.) Rod and Bar (Angled)  
Pipe Material: **Clay** ☐ Pipe Lined  
Invert Depth: **13.20** (ft.) Flow Characteristics: **Fast**  
Deposits: ☒ None ☐ Mud ☐ Sludge ☐ Debris ☐ Grease  
Silt Depth: (in.) Deposits Extent:  
Infiltration: **None** Pipe Seal Cond: **Sound**

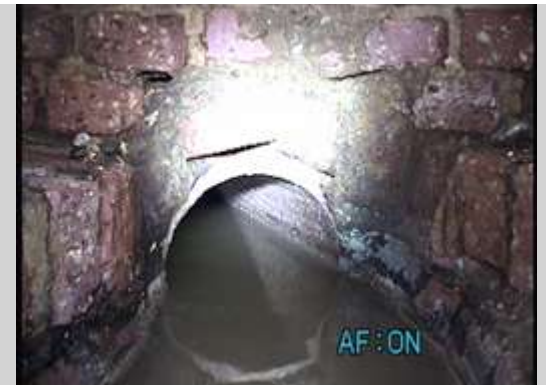
3 O'Clock Inflow

8 in. Circular Gravity Sewer  
Pipe In @ 3 O'Clock

Pipe Height: **8.4** (in.) Rod and Bar (Angled)  
Pipe Material: **Clay** ☐ Pipe Lined  
Invert Depth: **13.15** (ft.) Flow Characteristics: **Fast**  
Deposits: ☒ None ☐ Mud ☐ Sludge ☐ Debris ☐ Grease  
Silt Depth: (in.) Deposits Extent:  
Infiltration: **None** Pipe Seal Cond: **Sound**

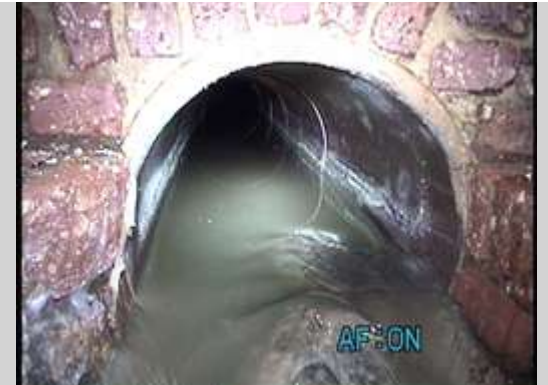
6 O'Clock Inflow

15 in. Circular Gravity Sewer

Pipe In @ 6 O'Clock

Pipe Height: **15.6** (in.) Rod and Bar (Angled)

Invert Depth: **13.05** (ft.) Flow Characteristics: **Fast**

Infiltration: **None** Pipe Seal Cond: **Sound**

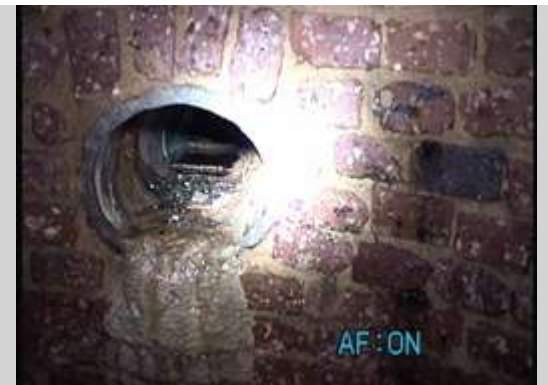
9 O'Clock Inflow

8 in. Circular Gravity Sewer

Pipe In @ 9 O'Clock

Pipe Height: **8.4** (in.) Rod and Bar (Angled)

Invert Depth: **8.10** (ft.) Flow Characteristics: **None**

Infiltration: **None** Pipe Seal Cond: **Sound**

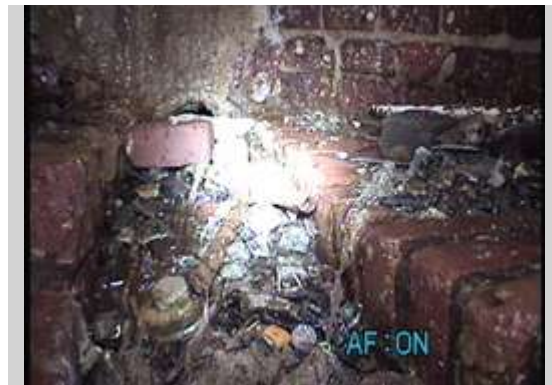
Drop In @ 9 O'Clock

Drop: **Inside** Rod and Bar  
Angled: **Yes** Reading: **11.50** (ft.)  
Inv Depth: **12.50** (ft.)  
Drop Condition: **Open**
